Fractography of clinically fractured, implant-supported dental computer-aided design and computer-aided manufacturing crowns

Published in:
SAGE open medical case reports

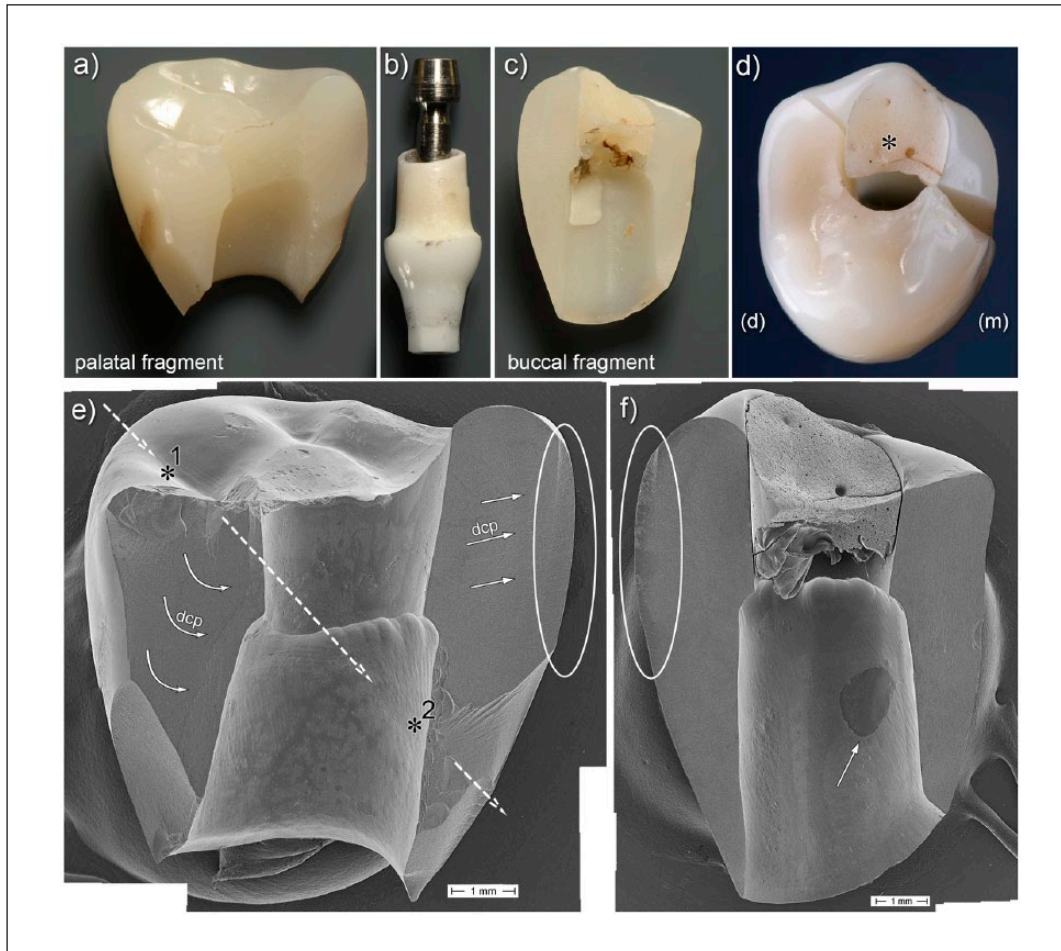
Figure 1. (a–d) Photographs of the crown and the abutment of case 1. The crown fractured mesio (m)- distally (d) in two fragments, while some minor fragments on the mesial side went missing, most likely during intraoral fracture. (b) Luting remnants can be found on the implant abutment surface. (d) The screw hole clinically filled with glass ionomer cement (*). (e and f) Higher resolution SEM images (mapped from individual SEM images) from the fracture surfaces of the fragments shown in (a) and (c). Both fragments exhibit the corresponding compression curl (circle), indicating the termination of the fracture event. (e) The palatal fragment shows clear fracture patterns on the cusp of the mesial proximal ridge (*1) and on the intaglio side of the disto-buccal margin (*2). The buccal fragment shows only minor luting remnants on the intaglio side (arrow). Most of the yellowish luting remnants are found on the zirconia abutment (b), indicating the crown–adhesive interface as the weakest link. In consequence, it seems very likely that the crown fracture was preceded by a debonding event, most likely leading to wedging of the crown and subsequent inclined shear loading in the direction assigned in (e) (dotted arrows). The fracture origin on the distal intaglio surface (*2) is thus termed a secondary event leading to abfraction of the missing marginal fragment. (e) The general direction of crack propagation (dcp) is indicated with arrows. The fracture started on the mesial side and ended on the disto-buccal side.

This crown was retrieved from tooth #14 of a 60-year-old male patient and fractured after 2 months in situ without any complications or reported malfunction. The fractographic examination is presented in Figures 1 and 2.

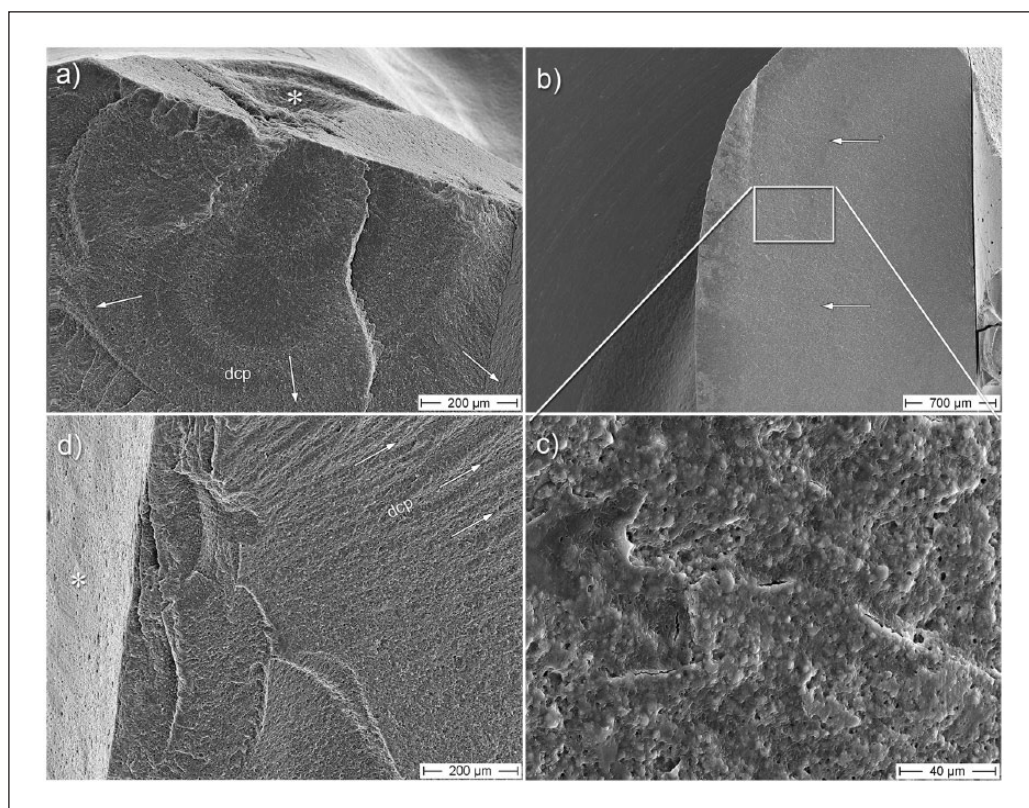
Figure 2. (a) The fracture origin on the palatal fragment of Figure 1 (e) (see *1). A large wear facet and damage accumulation zone can be seen on the surface (*) as well as multiple and overlaying mist and hackle regions and radial crack extension (arrows). (b) A magnification of the compression curl of Figure 1 (e) and (f), the endpoint of the fracture event on the disto-buccal side of the crown. (c) A high magnification of a fracture region close to the compression curl in (b). Small cracks are observable hypothesizing a degradation artifact in the microstructure of the resin composite crown material. (d) The secondary fracture event. Hackle indicates the dcp (arrows) radial from the fracture origin. (d) A clean intaglio surface (*) without any remnants of the luting agents, indicating an adhesive failure at the crown–adhesive interface.

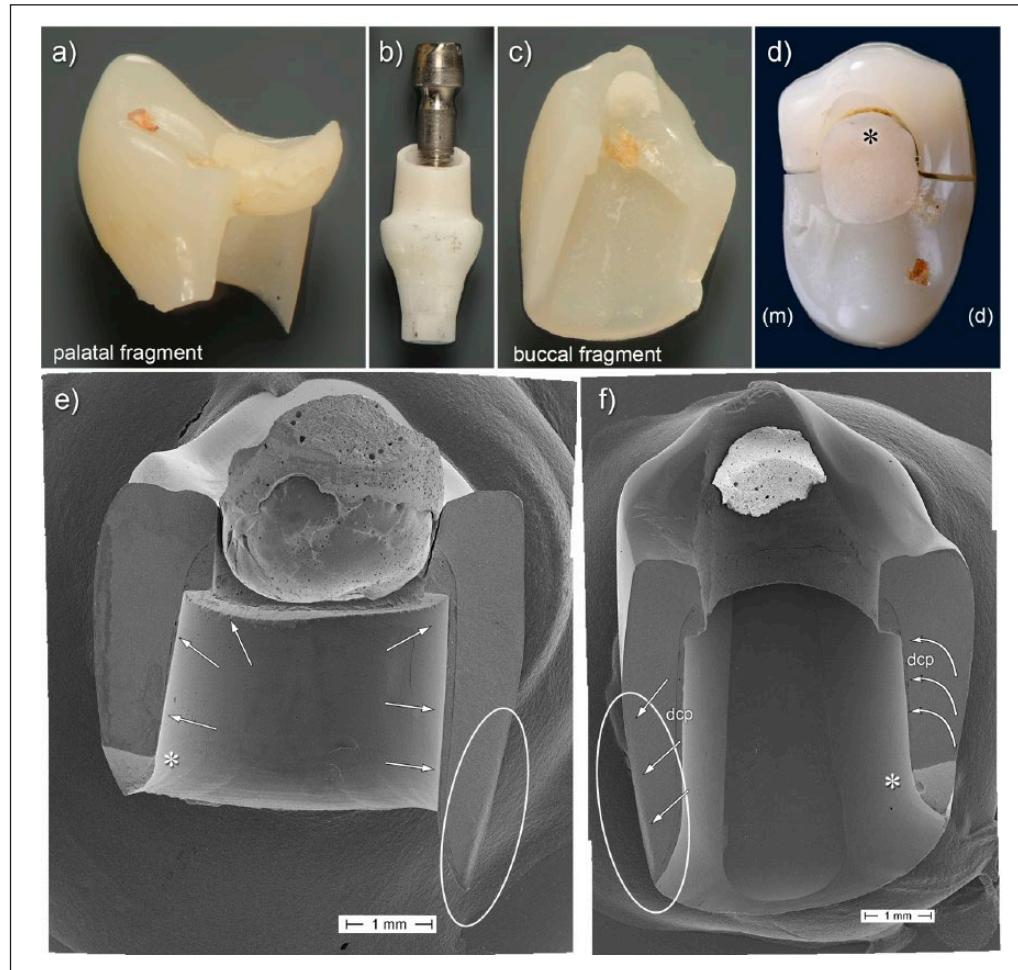
This crown was retrieved from tooth #25 of a 39-year-old female patient and fractured after 5 months in situ without any signs of malfunction. The fractographic examination is presented in Figures 3 and 4.

Figure 3. (a–d) Photographs of the crown and the implant abutment of case 2. The crown fractured mesio (m)–distally (d) in two fragments. (b) The zirconia abutment was found free of luting remnants. (d) The screw hole clinically filled with glass ionomer cement (*). (e) and (f) Higher resolution SEM images (mapped from individual SEM images) from the fracture surfaces of the fragments shown in (a) and (c). Both fragments exhibit the corresponding compression curl on the mesial margins (circles), indicating the termination of the fracture event. On the opposite (distal) margins, (e) and (f) shows a sharp and tilted fracture plane, suggesting the fracture initiation site at the marginal ridge (*). A clear fracture origin cannot be located, but fine hackle lines trace back to the marginal ridge, as shown in Figure 4(d). Luting remnants can be found only on the crown intaglio surface as indicated by the arrows in (e), indicating the zirconia–adhesive interface as the weakest link. It is likely that the fracture was preceded by a debonding event, resulting in tilting of the crown and shear fracture originating from the crown margins. (f) The general direction of crack propagation (dcp) is indicated by arrows. The fracture started on the distal side and terminated on the cervical mesial margin.

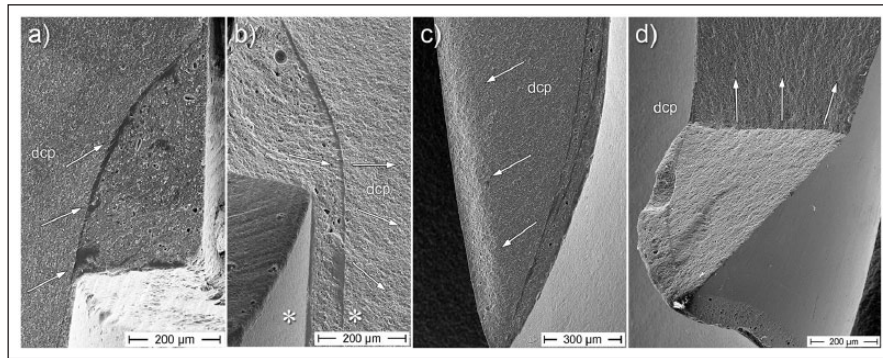
Figure 4. (a–d) High-resolution SEM images from the luting layer (Figure 3(a, b), the compression curl (Figure 3(c)) and the fracture initiation site (Figure 3(d)). While Figure 3(a) and (b) is taken from the palatal fragment, Figure 3(c) and (d) is taken from the buccal fragment. Figure 3(a) and (b) clearly show the adhesive layer on the zirconia–adhesive side as well as on the crown–adhesive side with the sandwich luting agent in between (see * in (b)). The dcp can be seen from fine hackle lines, especially in the smooth and flat adhesive layer, indicated by arrows in Figure 3(a) and (b). Figure 3(c) and (d) also shows the luting layer and the dcp, indicated by arrows. An overview of the general dcp is shown in Figure 3(f).

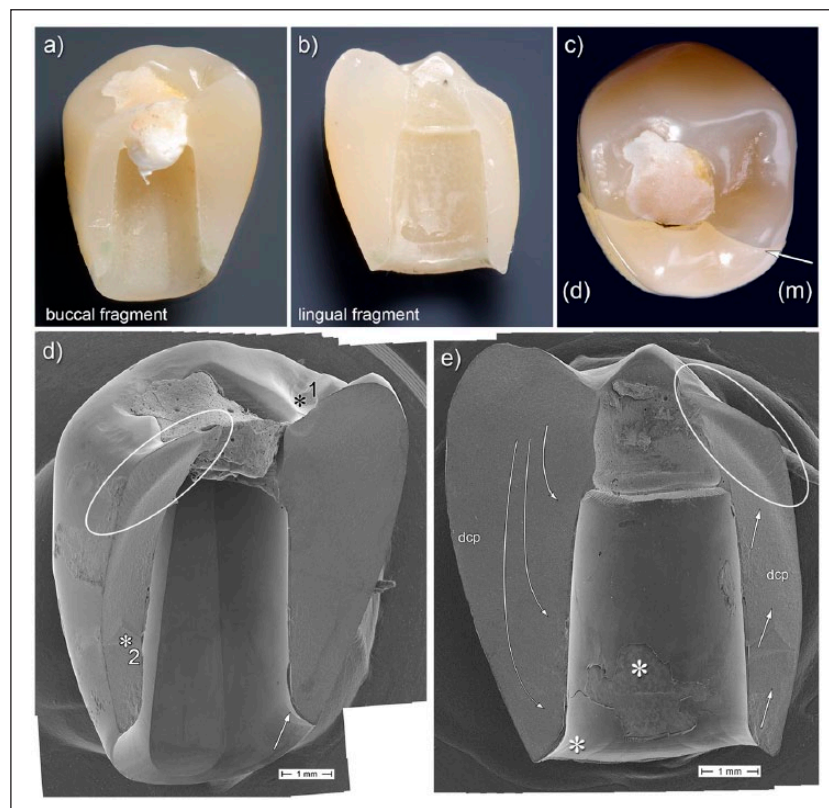
This crown was retrieved from tooth #35 of a 24-year-old male patient and fractured after 4 months in situ. The patient reported that he felt loosening of the crown before mastication fracture. The fractographic examination is presented in Figures 5 and 6.

Figure 5. (a and b) Photographs of the retrieved fragments of case 3. The crown fractured mesio (m)–distally (d) in two fragments. The corresponding abutment was not available for fractographic analysis due to further patient treatment. (c) The occlusal view on the crown with the screw hole filled with glass ionomer cement (*) and the fracture plane eccentrically located on the lingual side, separating the lingual cusp (arrow). Interestingly, the fracture started on the massive and bulky lingual cusp which indicates an unbalanced masticatory loading. (d and e) Higher resolution SEM images (mapped from individual SEM images) from the fracture surfaces of the fragments shown in (a) and (b). Both fragments exhibit the corresponding compression curl on the distal side (circles), indicating the termination of the fracture event. On the opposite (mesio-lingual) side, (d) clearly shows the fracture origin (*1). A secondary fracture event is further located on the inner plane on the gingival third of the distal margin (*2). Fine hackle lines, especially in the adhesive layer (see further analysis in Figure 6), trace the general dcp as indicated in (e). The fracture started on the mesio-lingual cusp and terminated on the distal side. Luting remnants can be found on the crown intaglio surface. Some remnants broke off, as shown in (d) (arrow) and (e) (*). The luting layer tends to delaminate from either the crown or the zirconia abutment. In principle, both adhesive interfaces (but predominantly the adhesive–zirconia interface) represent the weak link leading to crown debonding.

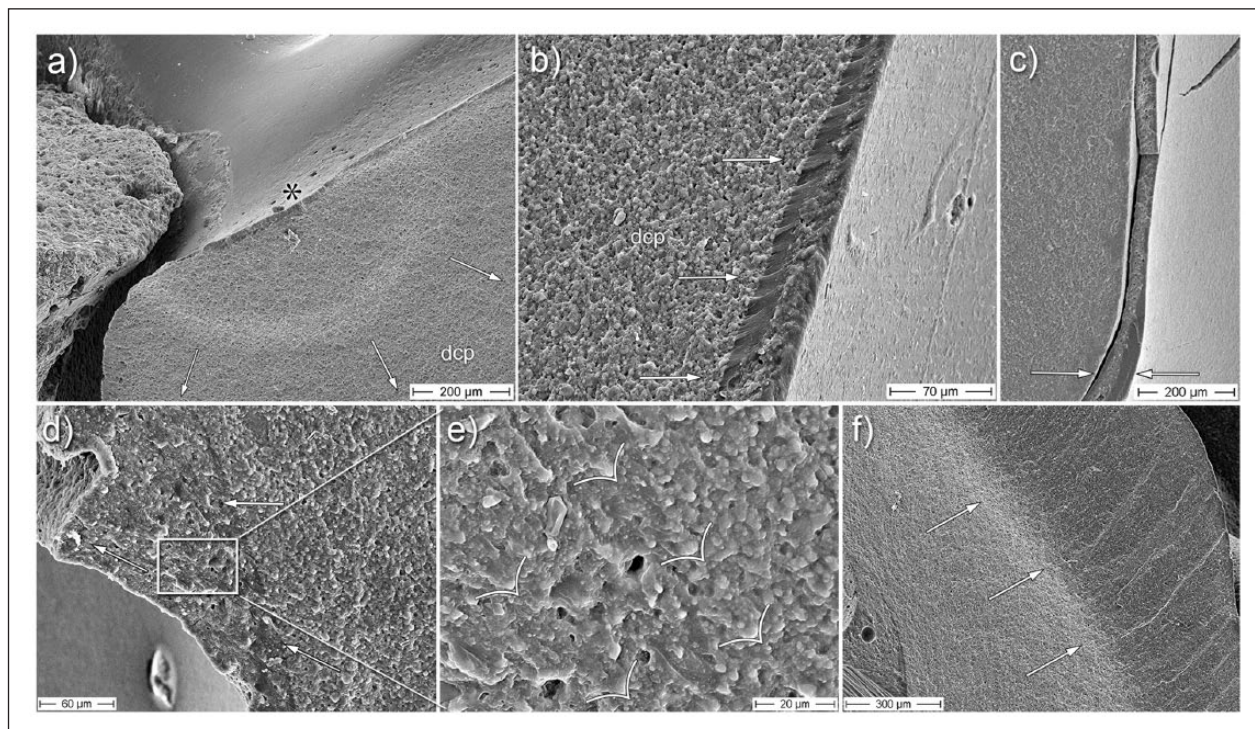
Figure 6. (a–e) High-resolution SEM images from the (a) fracture origin (b–e) luting layer, (f) the compression curl. While (a) is taken from the buccal fragment, (b–f) show magnifications of the lingual fragment. (a, b, d, f) Arrows indicate the dcp. (a) The fracture origin with a fracture releasing subsurface defect (*) and the radial fracture mirror and hackle region. The microstructure of the resin-based crown material did not elucidate distinct fractographic patterns. (b) The smooth adhesive layer, on the other hand, clearly indicates the dcp. Parallel, crazing-like hackle lines are found. (c) Delamination of the luting layer occurred mainly from the zirconia abutment, but also from the crown surface (arrows). (d and e) Also, the microstructure of the luting agent indicates the dcp. A magnification of the microstructure in (e) exhibits gull-wing-like microstructural features indicating the dcp. (f) The compression curl as the endpoint of the fracture event.

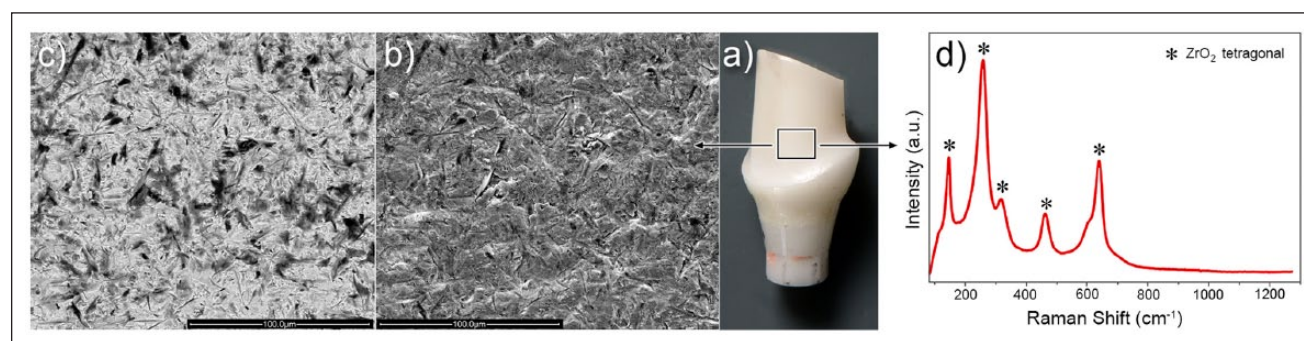
should conclude that adhesion is compromised. Sandblasting of tetragonal stabilized zirconia (TZP) is known to transform and degrade the microstructural cohesion of the zirconia (sub-) surface.^{22,23} Such degradation could have an effect on adhesion as well. However, the Raman spectrum in Figure 7 confirms the sole existence of the tetragonal zirconia on the buccal side of the implant abutment and no signs of the monoclinic polymorph. Apparently, no substantial tetragonal-to-monoclinic phase transformation was induced during sandblasting, which suggests that the applied sandblasting procedure (< 50 μm , 2 bar, 2–10 mm distance) was too soft. This would explain the absence of silica on the zirconia surface, as silica on

the silicatized alumina particles need impact energy to tribochemically adhere onto the zirconia surface.

Figure 7. (a) Analytical investigations on the buccal side of one debonded zirconia implant abutment. (b) SEM surface reveals rough patterns due to sandblasting. (c) EDS analysis did not show signs of silicon in the region of interest. (d) The Raman spectrum did only indicate tetragonal zirconia and no signs of silica.

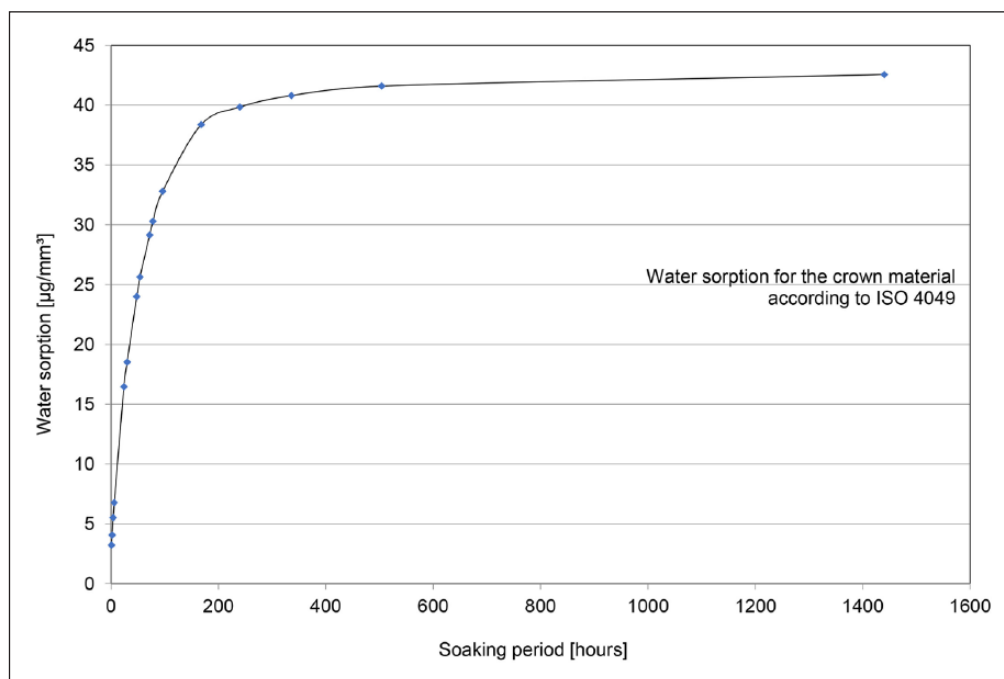
and to suffer from hydrolytic degradation and dimensional swelling to a certain extent.²⁵ Figure 8 shows a water saturation plot of the crown composite Lava Ultimate. The material takes up a maximum of 43 $\mu\text{g}/\text{mm}^3$ water over 2-month saturation period. The 95% water saturation level is already reached after 14 days of water storage. The maximum of 43 $\mu\text{g}/\text{mm}^3$ actually exceeds the maximum threshold value (40

$\mu\text{g}/\text{mm}^3$) in ISO 4049:2009 for polymer-based filling, restorative, and luting materials.¹² Although not measured, a relative dimensional change of a clinically placed crown can be assumed, based on the high amount of absorbed water, in turn increasing the stress state at the interface between crown and the zirconia abutment. Dental literature has not paid much attention to the swelling of resin luting agent, but indications

Figure 8. Water saturation curve for the resin-based composite Lava Ultimate over 2-month water storage period according to ISO 4049:2009. The material absorbed 43 $\mu\text{g}/\text{mm}^3$ water.
